### Bonded Fibre Reinforced Polymer Strengthening in a Real Fire

Proceedings of the First Asia-Pacific Conference on FRP in Structures (APFIS-2007)

## BONDED FIBRE REINFORCED POLYMER STRENGTHENING IN A REAL FIRE

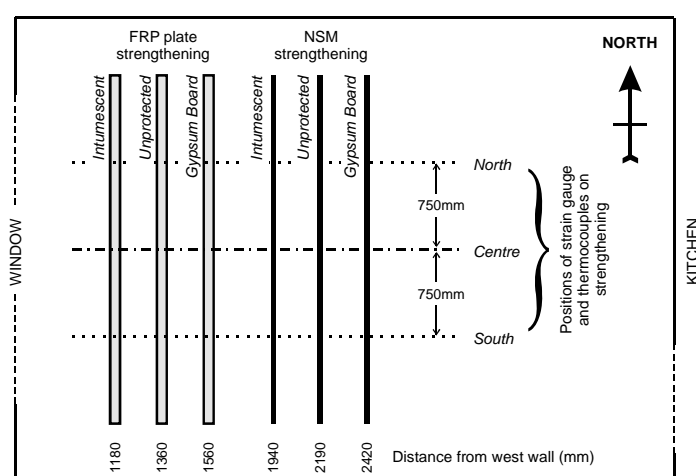
Figure 1. Schematic view of the strengthening.

Six strips of bonded FRP strengthening were installed in the compartment used in Test 1: three FRP plates and three near-surface-mounted (NSM) bars (Figures 1 and 2). The strengthening was installed by a contractor skilled in the application of bonded FRP and was completed 20 days before the fire test. The fire protection systems were installed by the University of Edinburgh. One of each type of strengthening was left unprotected, one painted with an intumescent coating, and one was protected within a gypsum board box. The gypsum board protection comprised two layers of 12mm board, spaced away from the bottom of the slab by a further two layers of board, placed to either side of the strengthening. The joints were staggered and the layers were sealed with an intumescent sealant. A single unprotected plate and unprotected NSM bar were installed in Test 2.

The fire tests took place in the living rooms of two flats, part of a 23-storey residential building that was built in 1964. The layout of the compartment is shown in Figures 1 and 2a. The fire load consisted of office furnishings, and was dominated by a sofa placed towards the east of the compartment. In the uncontrolled test, the compartment was ventilated by an open door to the rest of the flat and the openings left by breaking windows during the later stages of the fire. During the controlled test the ventilation parameters were changed by remote control of the windows and door (Abecassis Empis *et al.*, 2007).

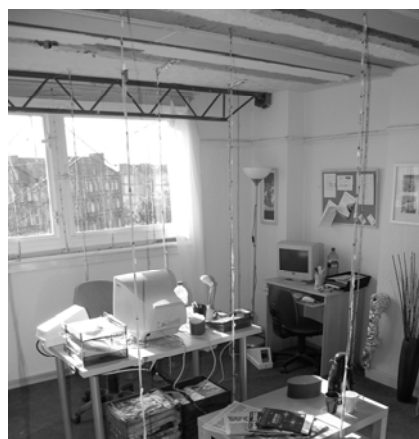
(a) Fire compartment, with FRP at top

Figure 2. The installed FRP strengthening and protection.

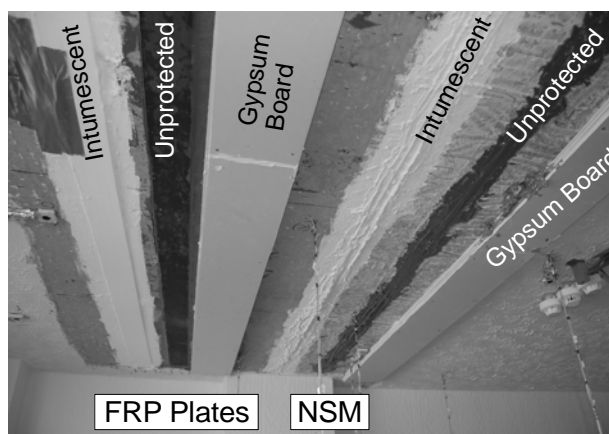
(b) The six strips of strengthening

Before installation, the FRP components in Test 1 were instrumented with strain gauges (attached to the upper surface of the FRP at the North, Centre and South positions shown in Figure 2), and thermocouples (placed within the adhesive layer at the same positions). The wires were led up through the concrete slab, with any holes filled using intumescent foam. A large quantity of additional instrumentation was used to record the progress of the fire and to monitor the structural response of the slab (Abecassis Empis et al., 2007).

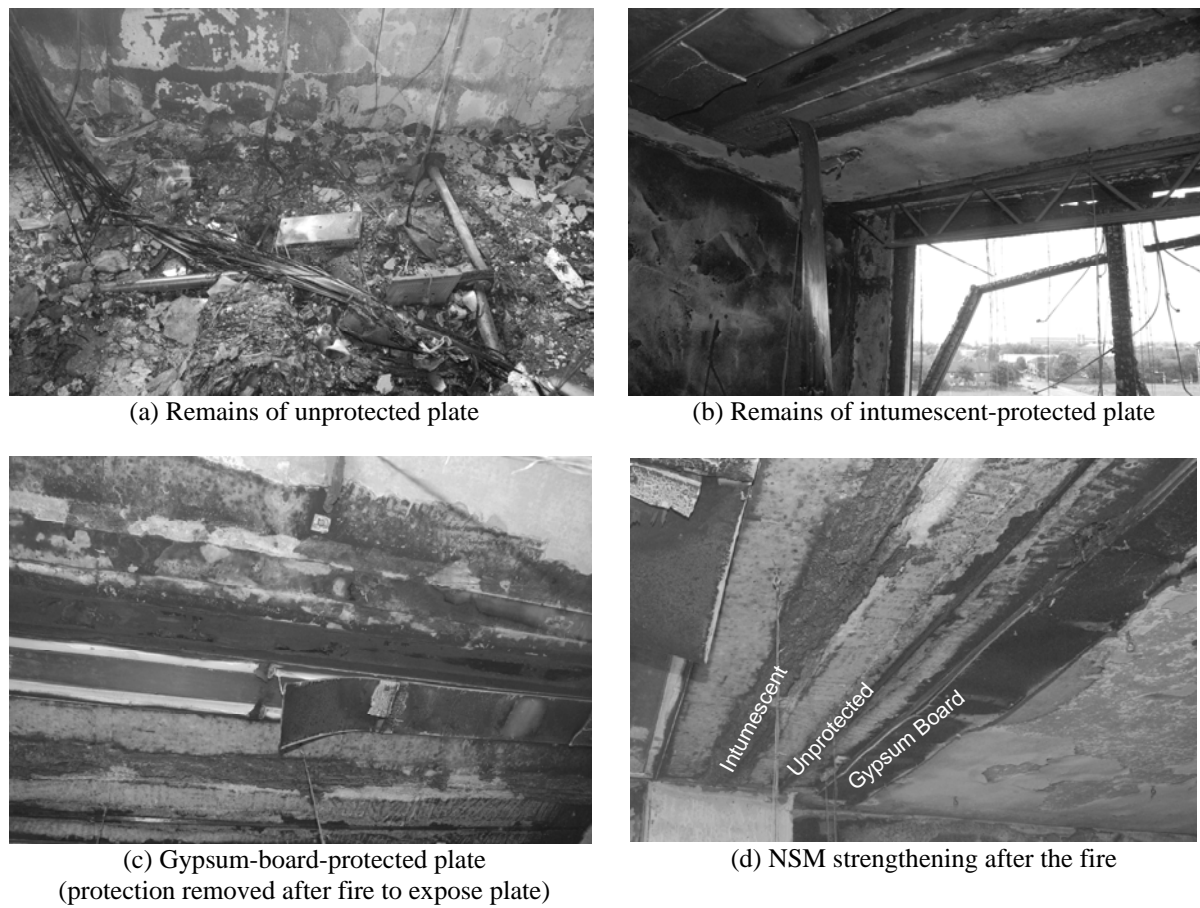
Figure 3. The condition of the bonded strengthening after the fire.

The condition of the bonded strengthening after the uncontrolled fire (Test 1) is shown in Figure 3:

- The unprotected plate (Figure 3a) had completely separated from the concrete. Both the bonding adhesive and the matrix polymer had burnt away, leaving exposed concrete on the ceiling and the bare fibres exposed on the floor.

- The intumescent protected plate (Figure 3b) separated from the concrete, except for a short length at its southern end, where it remained bonded to the concrete. Away from this end, the matrix polymer had burnt away to expose the fibres. The bonding adhesive was charred, but remained on the ceiling.

- The gypsum-board protection was inspected after the tests, and was fully intact. When the board was removed (Figure 3c), the plate was fully bonded to the concrete, and there was no *visual* damage to either the plate or adhesive. (Unfortunately it was not possible to carry out mechanical tests to quantify the post-fire properties).

- The adhesive around the unprotected NSM bar (Figure 3d) had burnt away, leaving the FRP partially exposed.
- The intumescent coating over the NSM strengthening (Figure 3d) had activated. The strengthening beneath the intumescent was in place, although the adhesive was glazed and contained transverse cracks.

- The gypsum-board protected NSM (Figure 3d) remained intact, and the strengthening beneath was visually unaltered.

Nevertheless, the uncorrected strain evolutions in Figure 5 are useful. Separation of the intumescent plate from the concrete, for example, occurred about 10 minutes from the start of the test, but the plate remained in contact at the southern end (confirmed by Figure 3b). The gypsum board protected strengthening have complete strain traces. The negative strains for the north gypsum-protected NSM gauge suggest the FRP has slipped relative to the concrete slab due to adhesive viscosity at high temperatures, but solidified during cooling. Further work, however, is required to analyse these results.

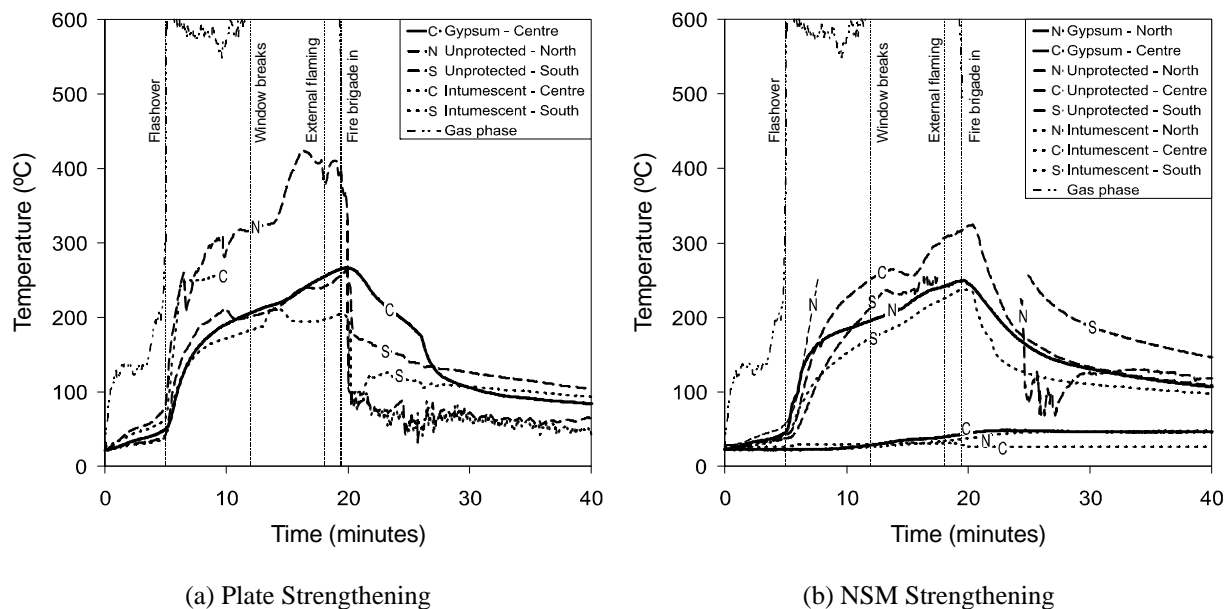
Figure 4. Bondline temperatures.

Figure 4 shows the temperatures recorded by the thermocouples in the FRP bondline for each type of strengthening and at each position (north, centre and south). Gas phase temperatures are included from a single thermocouple near the ceiling slab in the centre of the strengthened region, but it should be noted that the temperatures varied across the compartment. The figure indicates the major fire events: notably a growth period, ending with flashover at 5 minutes; and the fire was extinguished at 19 minutes (Abecassis Empis et al. (2007)). The uncontrolled fire produced a peak heat release rate of 800kW.

A few thermocouples were inactive (and are not shown), and the readings for 3 NSM thermocouples (gypsum-C, intumescent-N and intumescent-C) are erroneous. In all cases the bondline temperature exceeded the glass transition temperature of the adhesive. As expected, the bondline temperatures are highest in the unprotected plates, but even with gypsum-board protection, the glass transition temperature was reached less than a minute after flash-over. This is more rapid than previous furnace-based research (eg: Blondtrock et al. (2001)), which suggest that it takes in the order of 20 minutes for a similar temperature rise (although the protection system is not directly comparable). Without further analysis of the gas-phase temperatures it is not possible to draw comparisons between the plate and NSM temperatures.

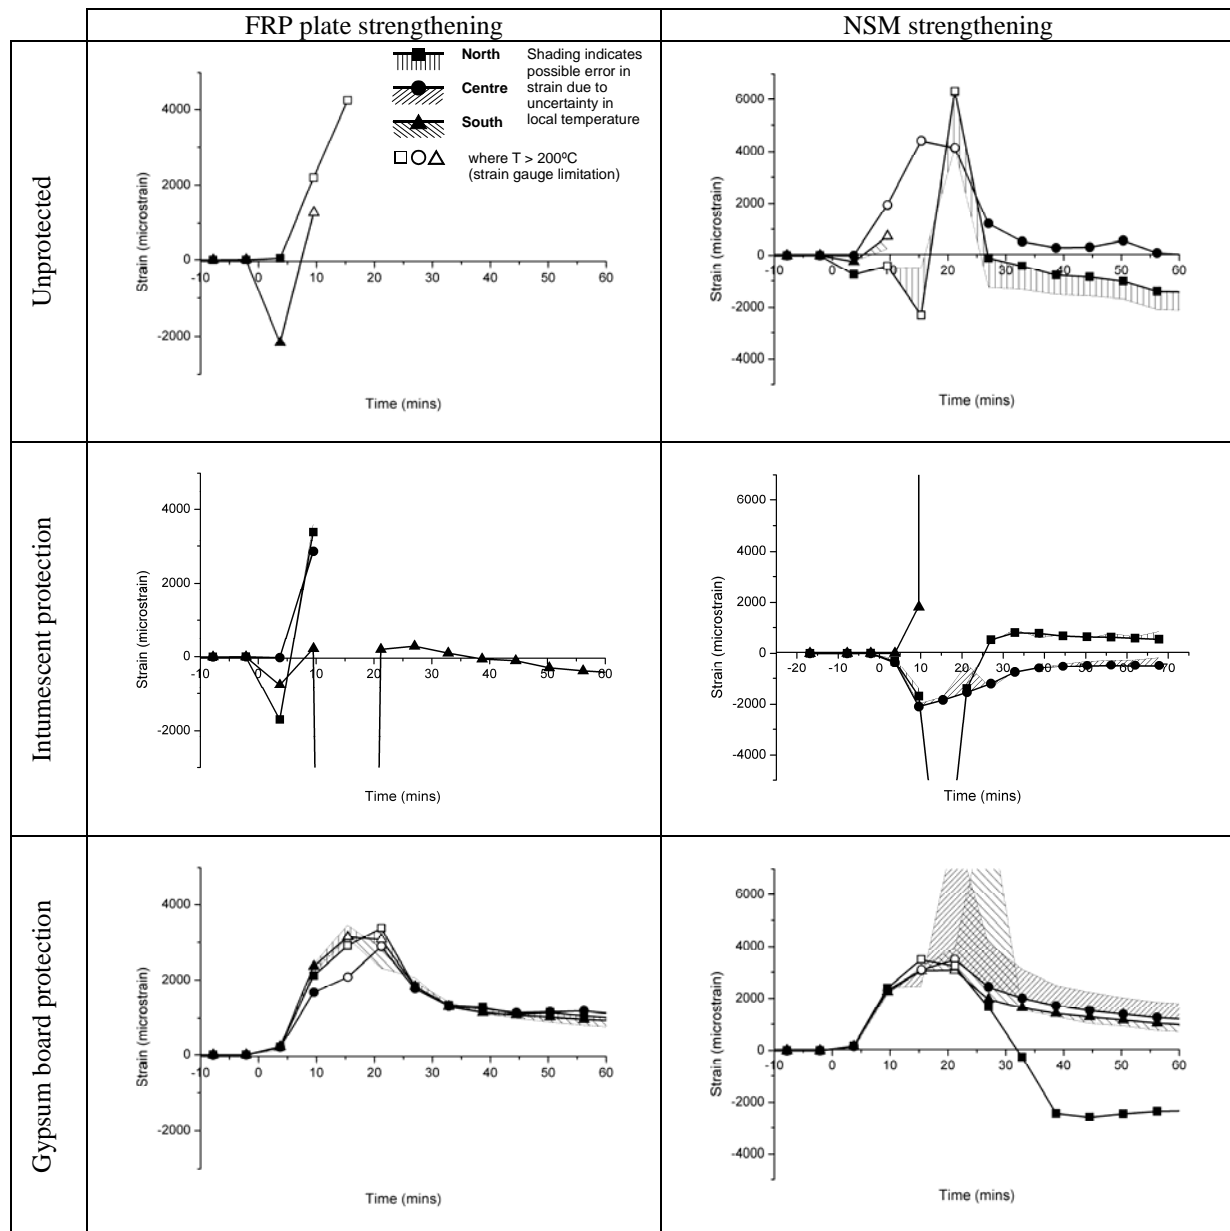
Figure 5. FRP strain measurements.

Figure 5 shows the strain gauge results. These are due to thermal expansion of the FRP, possibly in composite action with the concrete slab. The results have been corrected to remove temperature effects from (a) differential thermal expansion between the gauge and the FRP, (b) apparent strains due to electrical effects in the gauge and (c) variations in the gauge factor. The corrections are based on the bondline temperatures (Figure 4). If the thermocouple adjacent to the strain gauge was damaged, temperature data was taken from a different position in the same piece of strengthening. The temperature difference between the two locations was estimated by comparing gas phase temperatures, and the resulting uncertainty in the strain is indicated by the shaded regions in the figure. It is important to note that the strain gauges and gauge adhesive were only intended for use up to 200°C, consequently the correction will not be accurate and there may have been slip in the gauge adhesive above this temperature. Hollow symbols indicate such points in Figure 5. The time resolution of the data is poor, and the negative strains for the intumescent-protected NSM are anomalous.
